**HYDRAULIC MODEL  
INVESTIGATION**

**TECHNICAL REPORT NO. 171-1**

**Applegate Dam Spillway  
and Outlet Works  
Applegate River, Oregon**

**CONDUCTED BY  
DIVISION HYDRAULIC LABORATORY  
U. S. ARMY CORPS OF ENGINEERS  
NORTH PACIFIC DIVISION  
BONNEVILLE, OREGON**

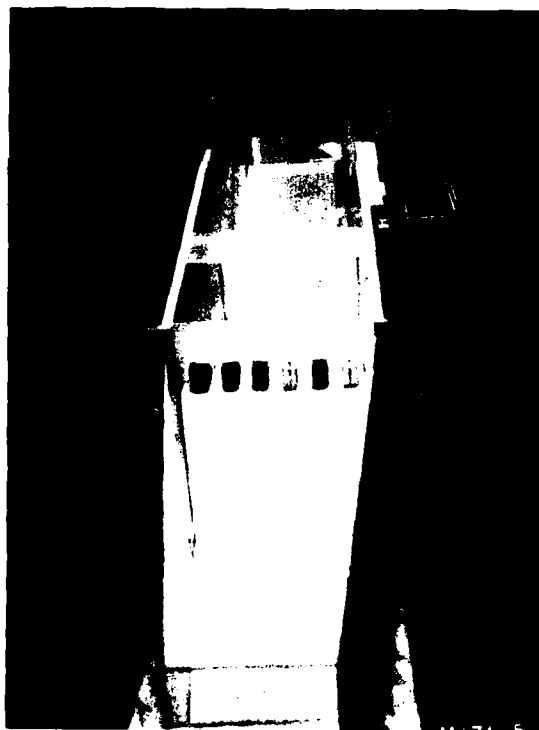
Photograph 9. Primary stilling basin.  
View from upstream.

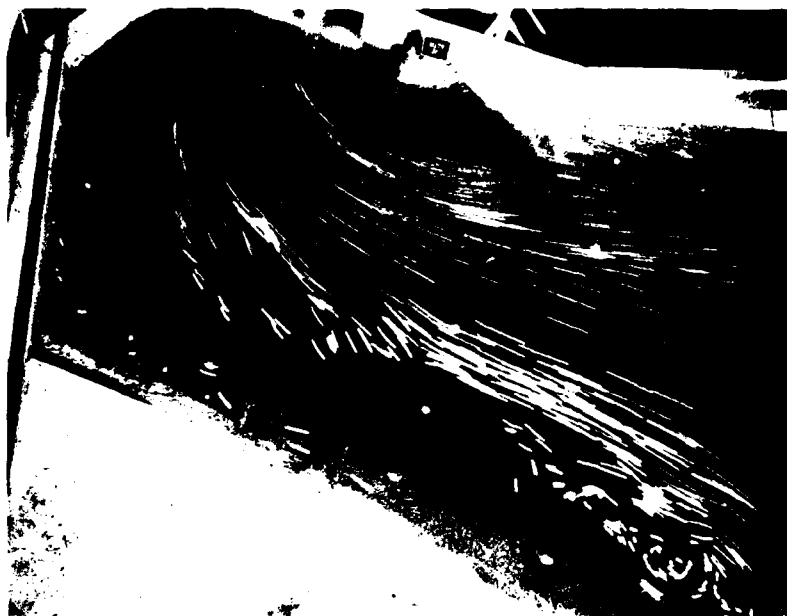
Photograph 15. Right bank abutment fill removed to elevation 1,970. Spillway approach channel at elevation 1,910,  $p/H_d = 0.78$ . Spillway discharge 93,600 cfs. Pool elevation 1,985.

11. The approach channel invert was raised to elevations 1900 and 1910 and tested with the spillway design discharge. Hydraulic performance was acceptable under both conditions (see photographs 13 and 14). The tests indicated that the flow conditions would be good also with a higher invert; however, none was tested because part of the channel had already been excavated to elevation 1910. Removal of the embankment fill at the left abutment to a rock bench at elevation 1970 increased local velocities at the fill from 5 fps (occurring with the fill) to 8 to 11 fps (during SDF conditions) and created generally poorer surface flow conditions upstream of the spillway crest (see photograph 15). Removal of the fill had little noticeable effect on flow through the spillway and in the chute.

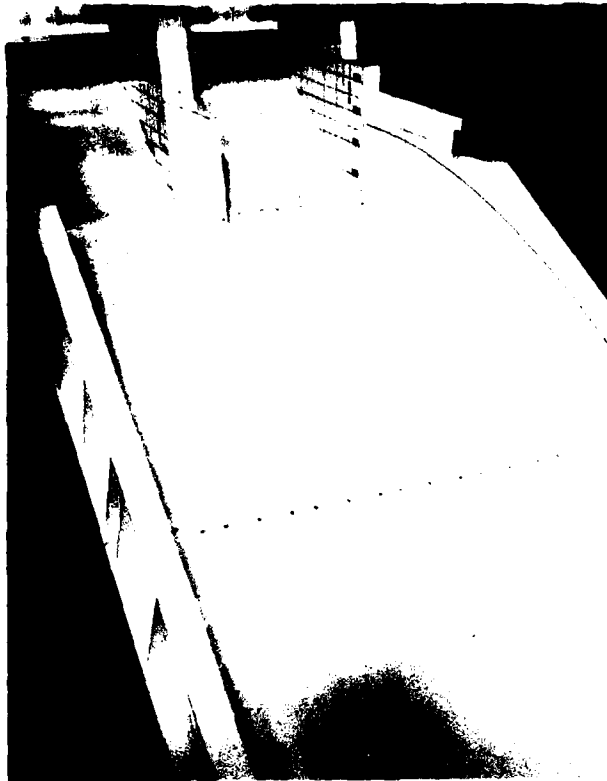
Photograph 18. Spillway pier extension.

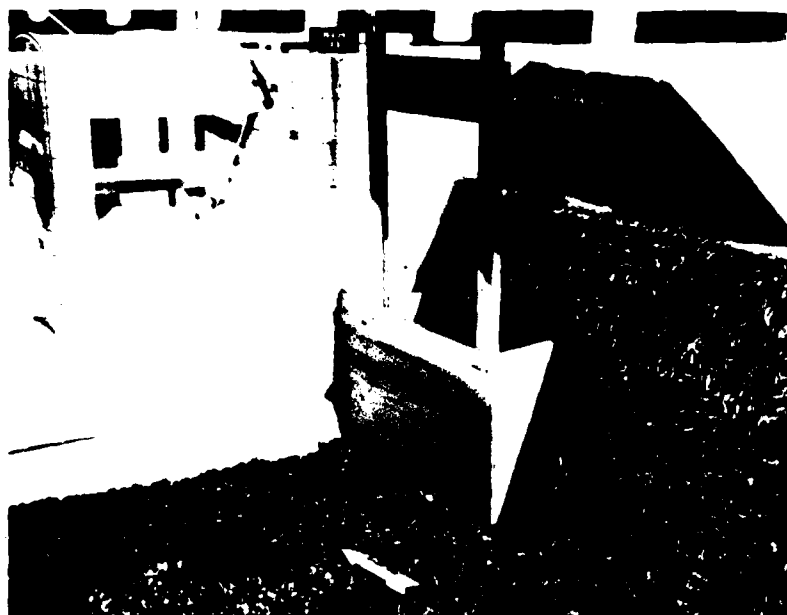
Photograph 20. Vertical wall extending upstream from right spillway abutment.

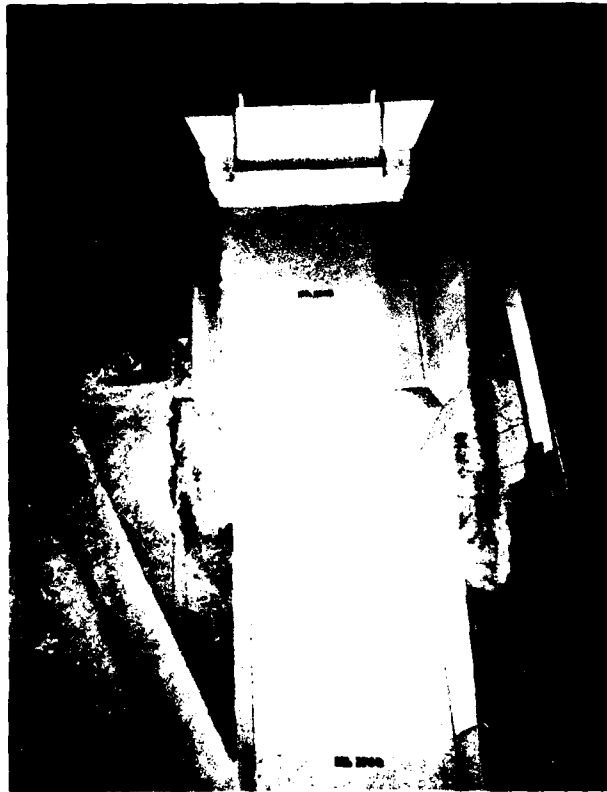
Photograph 25. Original design plunge pool and downstream channel.

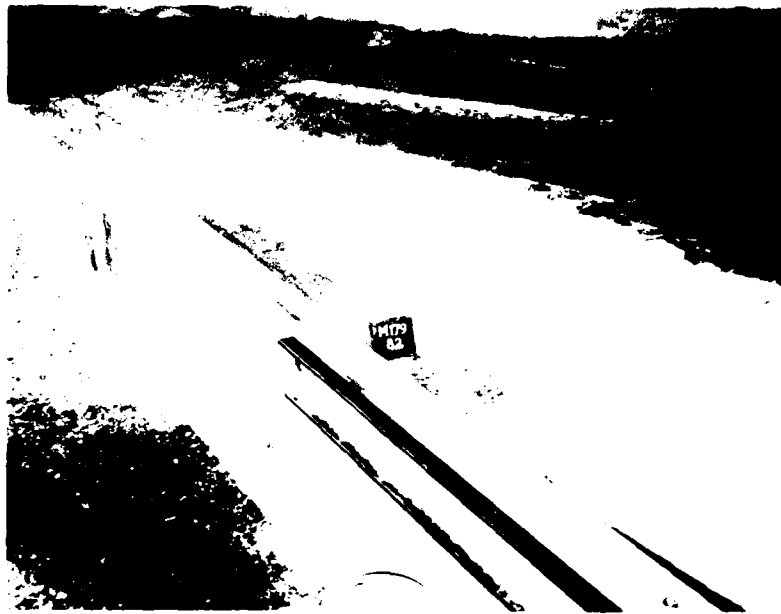
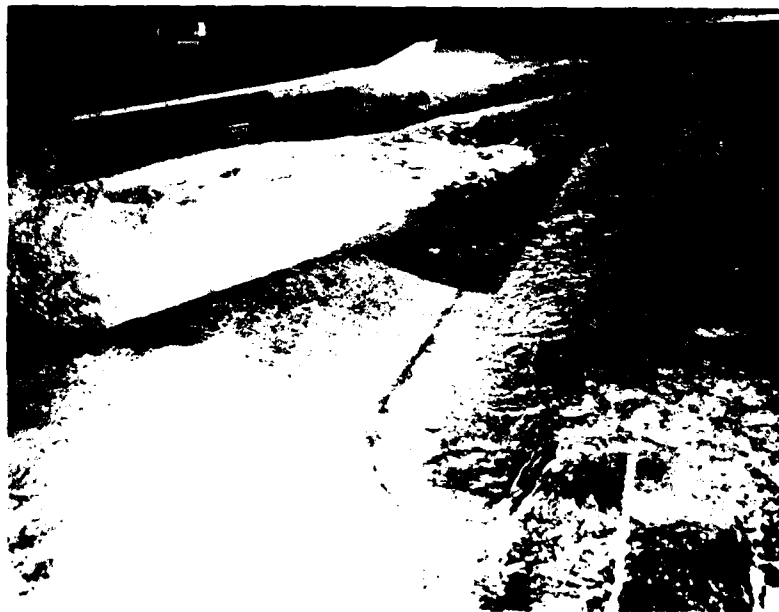
Photograph 27e. Left bank.

Photograph 27f. Right bank.

Original design plunge pool and downstream channel.  
Spillway discharge 29,700 cfs.

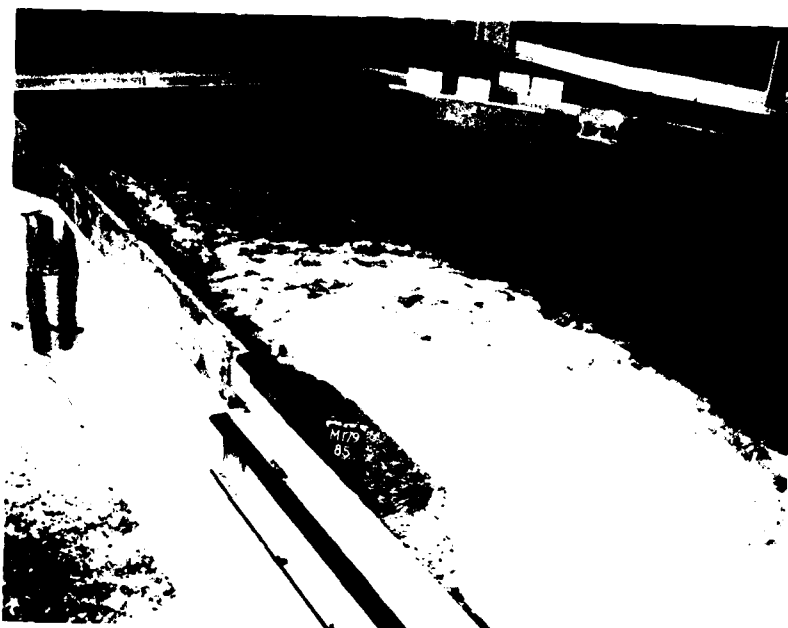
Photograph 28e. Left bank.

Photograph 28f. Right bank.

Original design plunge pool and downstream channel.  
Spillway discharge 43,900 cfs.

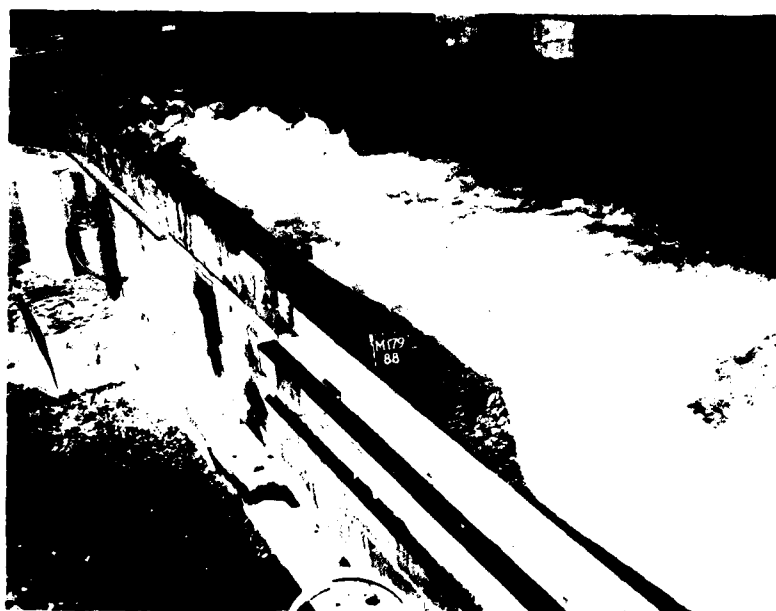
Photograph 29b. Left bank.

Photograph 29c. Right bank.

Original design plunge pool and downstream channel.  
Spillway discharge 93,600 cfs.

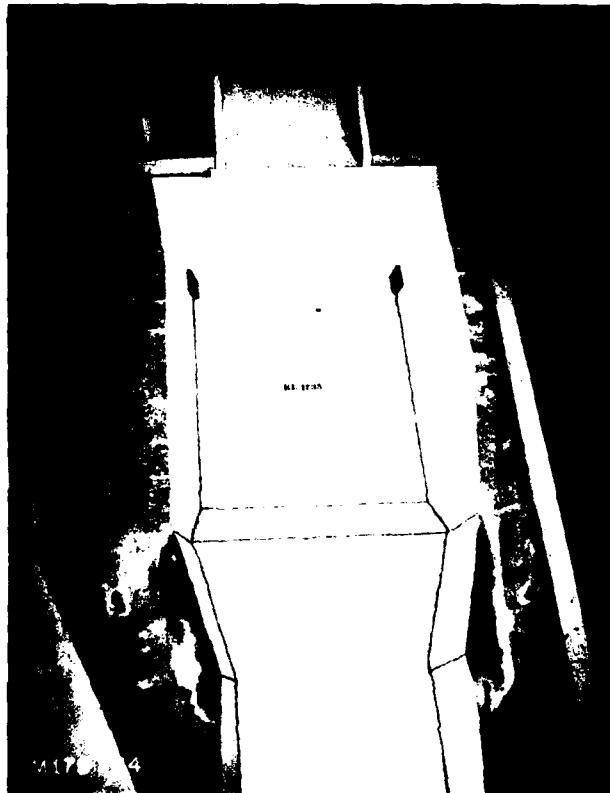
Photograph 30. Revised left and right bank transition downstream from plunge pool.

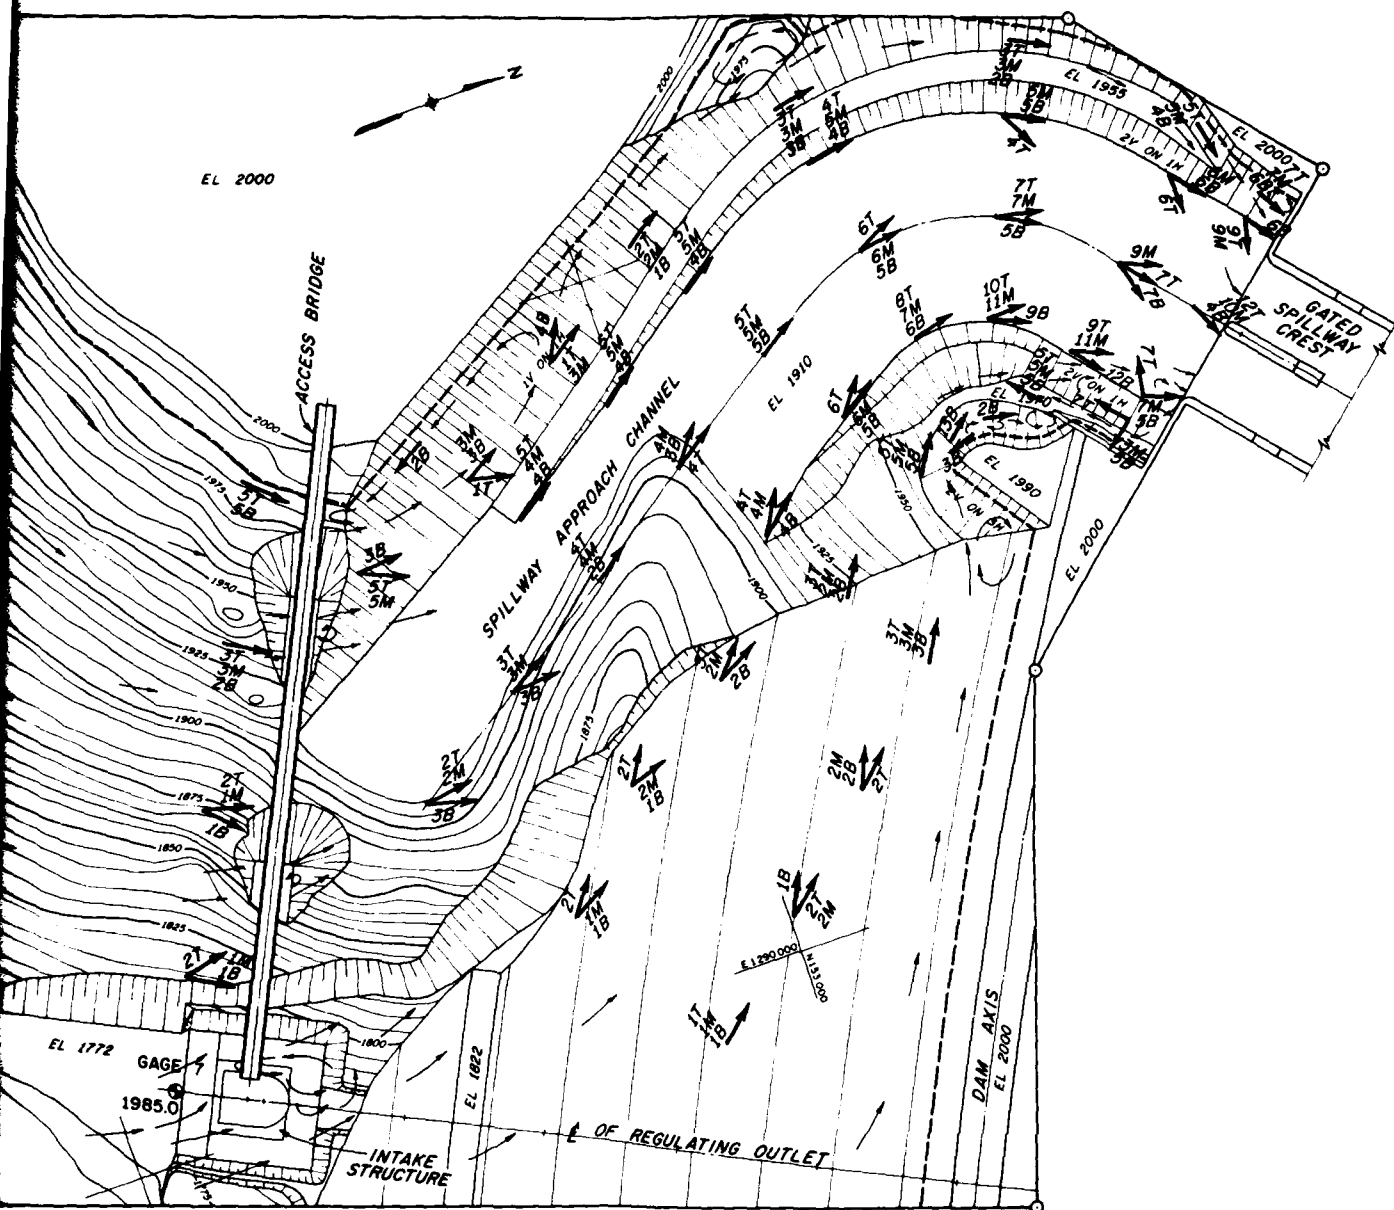
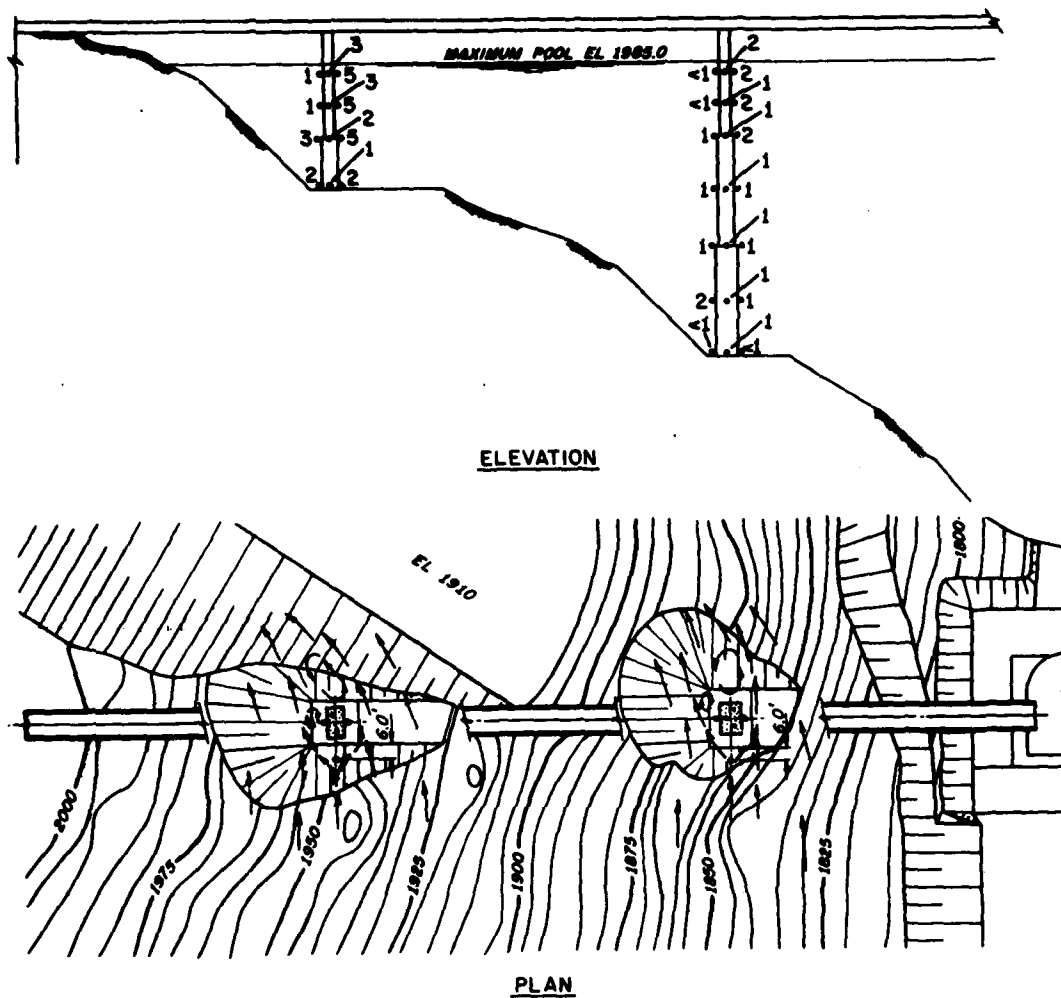
**FLOW CONDITIONS  
 AT BRIDGE PIERS**

RIVER DISCHARGE 99 500 CFS

13. Tests were accomplished to evaluate flow conditions around the outlet intake structure bridge piers (plate 7). Plate 8 shows velocities and flow conditions around the bridge piers with the SDF condition. Maximum velocity around the piers was 5 fps, with a maximum velocity of 2 fps near the pier footing.

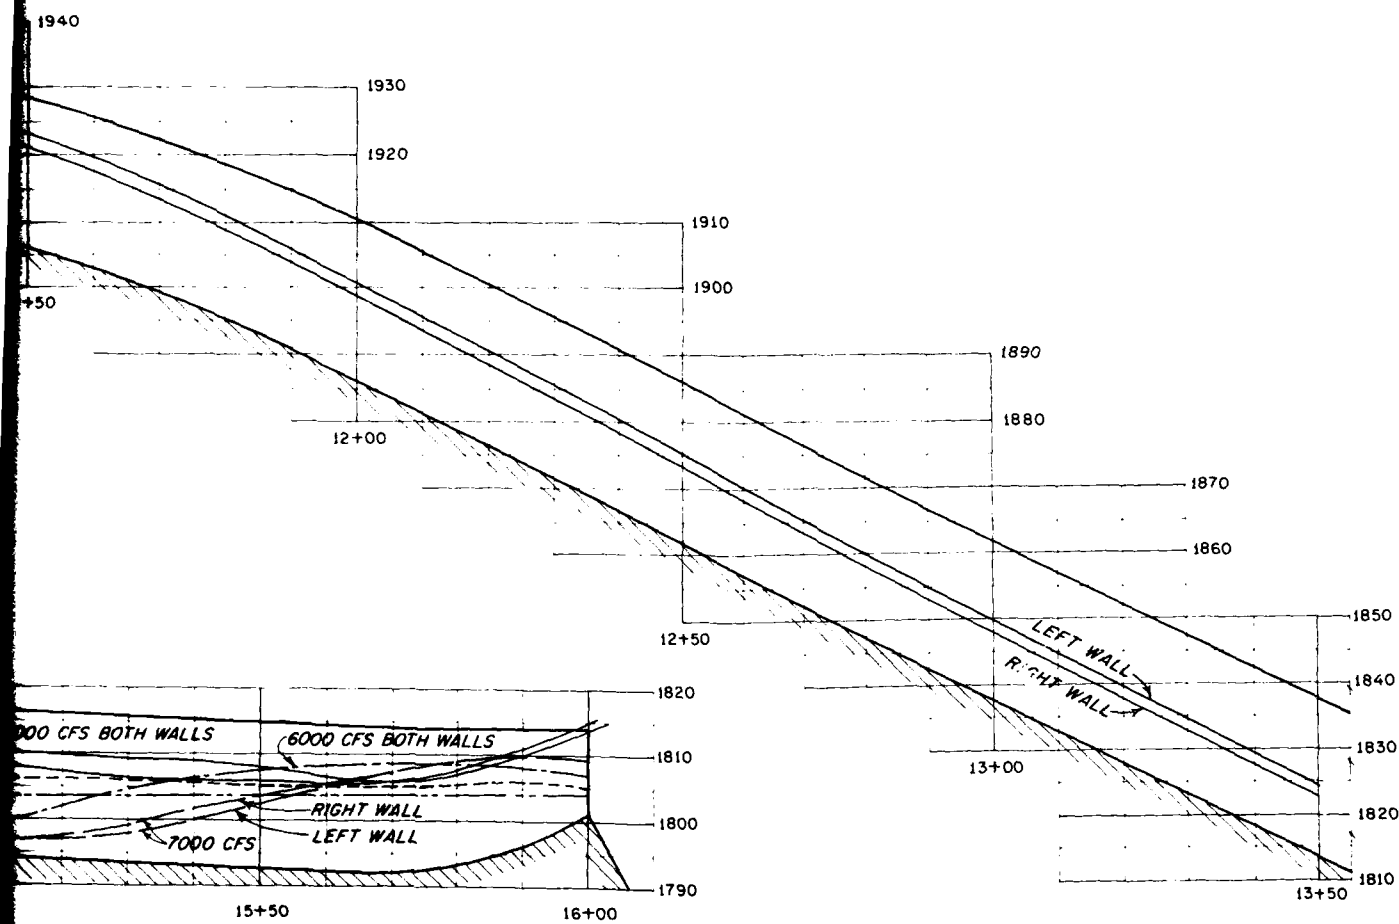
WATER-SURFACE PROFILES  
ON WALLS  
WITH PIER EXTENSION

15. A 32-foot-long pier extension (photograph 18) was developed that greatly reduced the rooster tail (photograph 19); however, the modification did not improve flow conditions in the chute. A vertical wall 35 feet above the approach channel invert extending 50 feet upstream from the right abutment (photograph 20) improved the inflow to the spillway and caused a 2-foot lower water surface profile (SDF) on the left wall of the chute between station 14+35 and station 14+50. Water surface profiles in the chute with the pier extension and both with and without the forebay wall are shown on plates 10 and 11, respectively. The changes in spillway operating performance resulting from both modifications were considered to be largely aesthetic, and neither modification offered a significant enough improvement to warrant their additional cost. Passage of the SDF through the spillway with a pool elevation 2 feet lower than maximum design pool indicated that the spillway could have been slightly smaller. Because a portion of the spillway area had already been excavated, tests to refine the spillway size were not made.

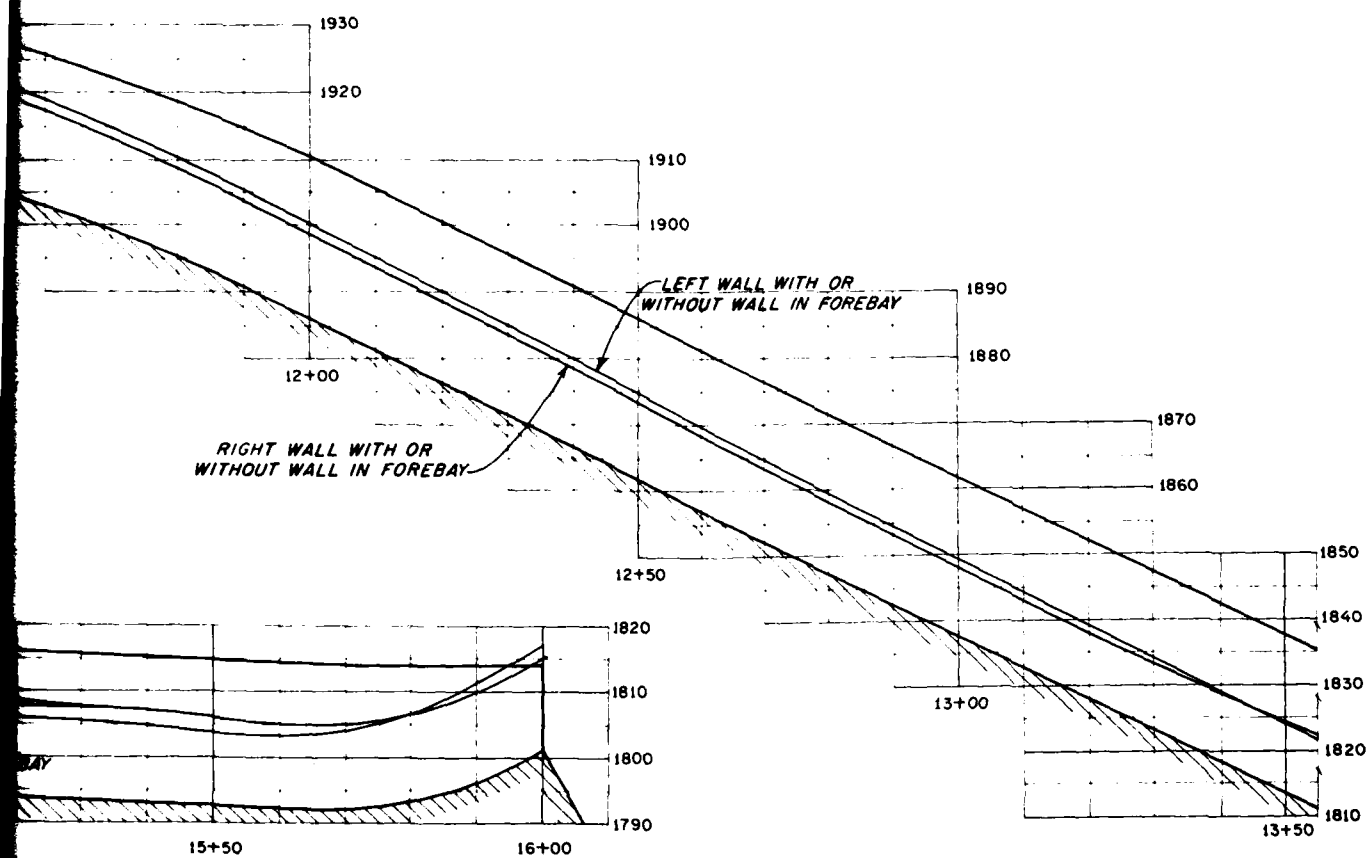
WATER-SURFACE PROFILES  
ON WALLS  
WITH AND WITHOUT FOREBAY WALL  
SPILLWAY DISCHARGE 93600 CFS

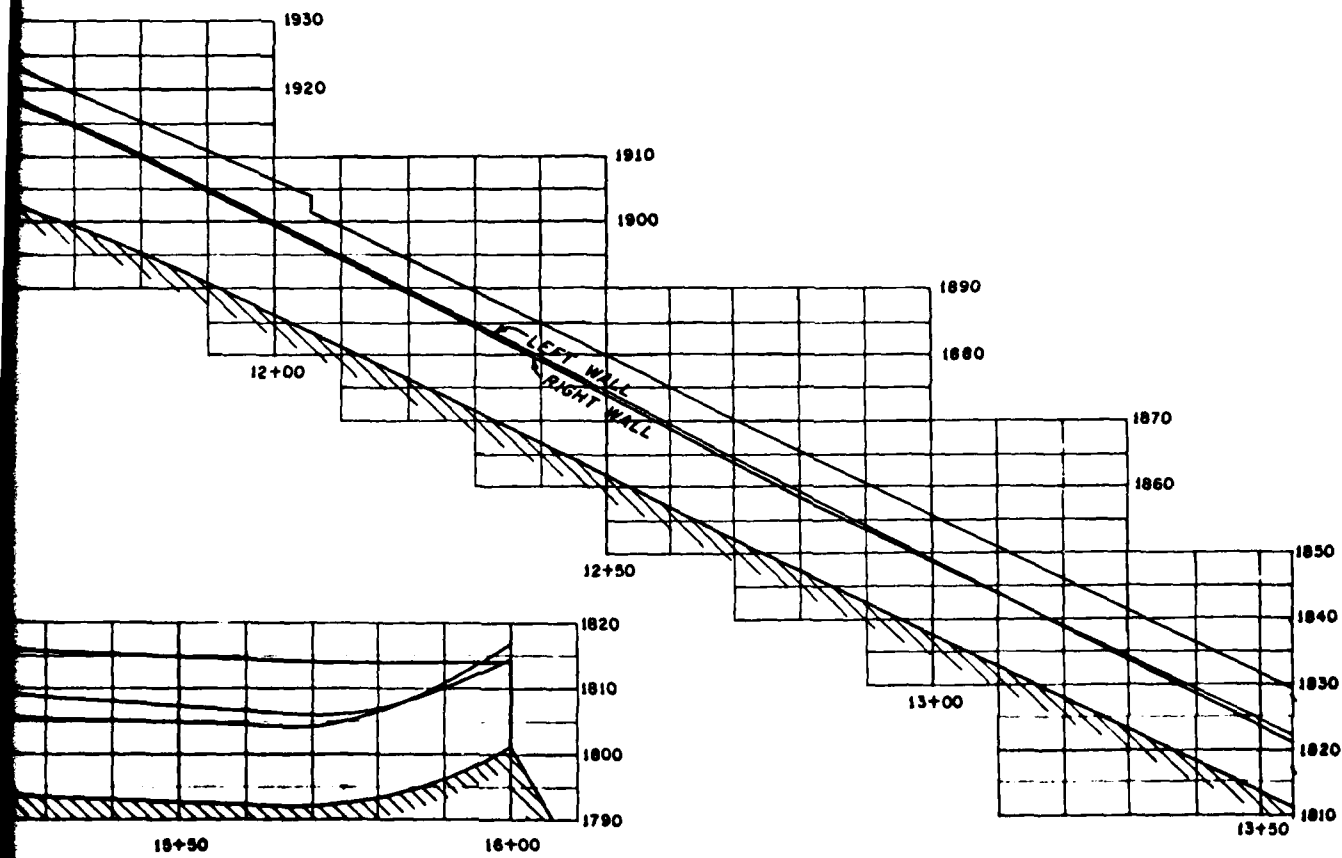
WATER-SURFACE PROFILES  
ON WALLS  
FINAL DESIGN  
RIVER DISCHARGE 93 600 CFS

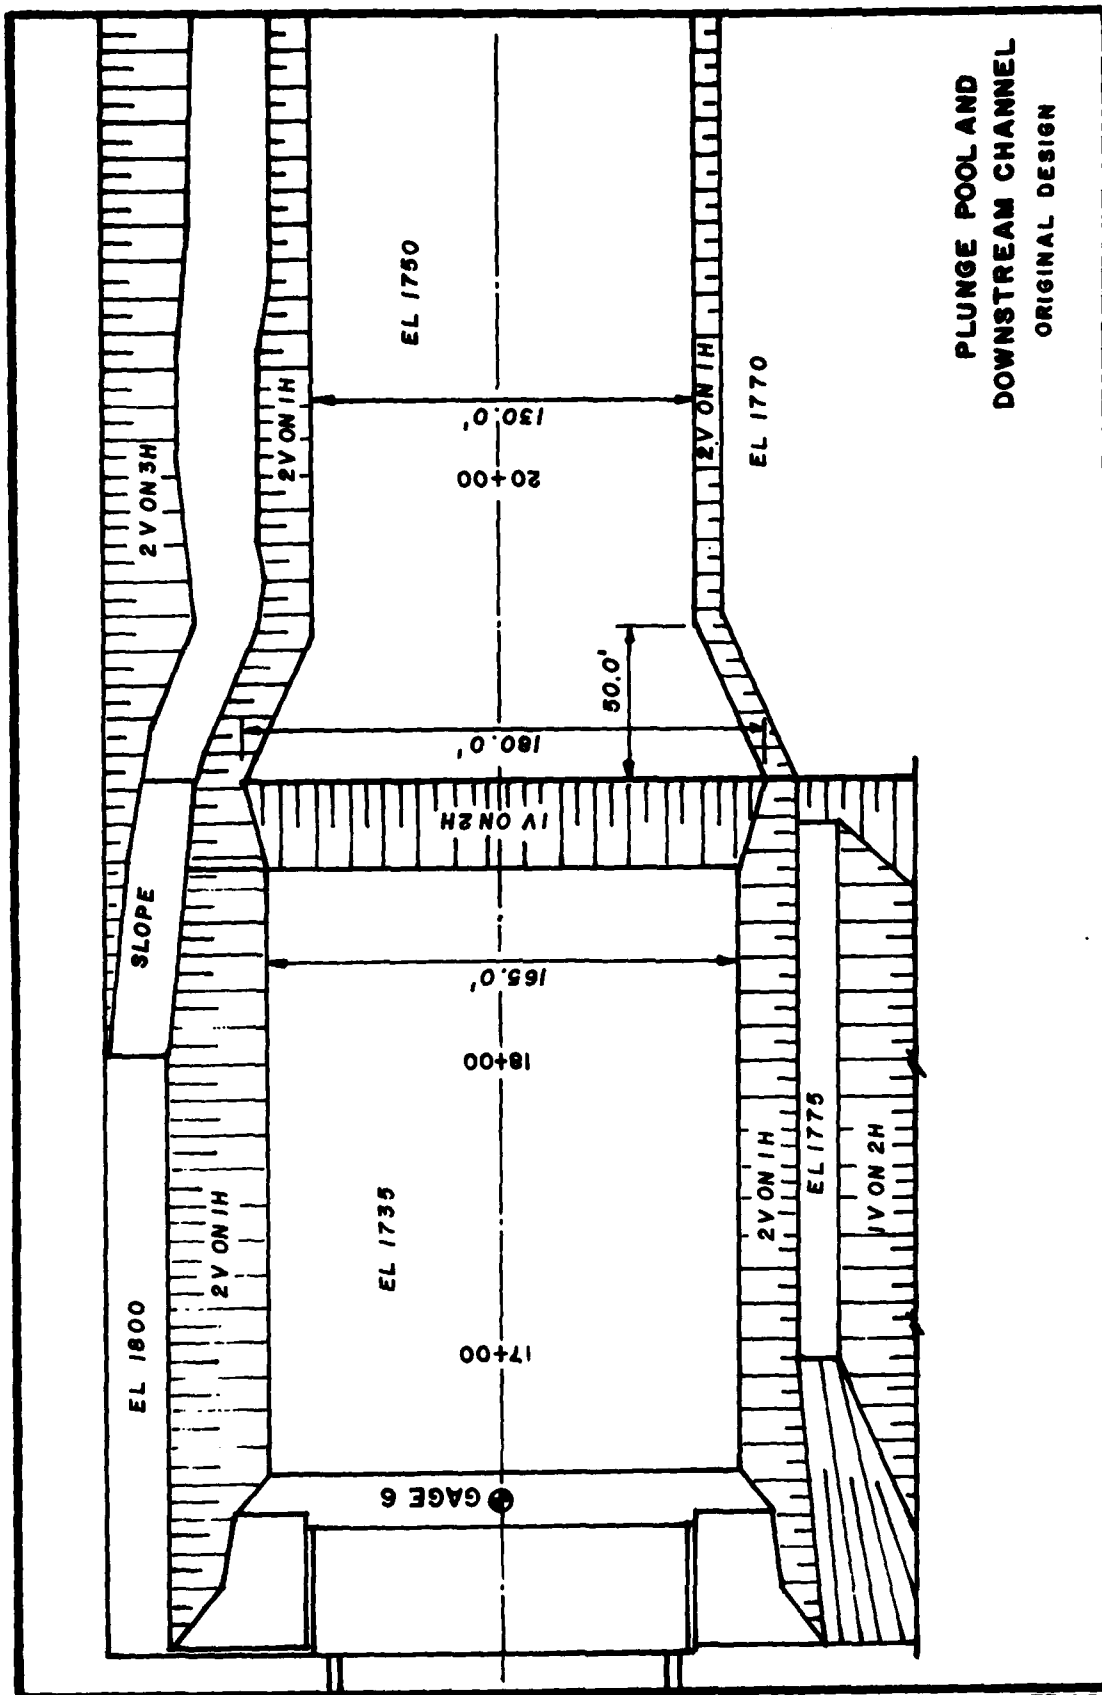
PLUNGE POOL AND  
DOWNSTREAM CHANNEL  
ORIGINAL DESIGN

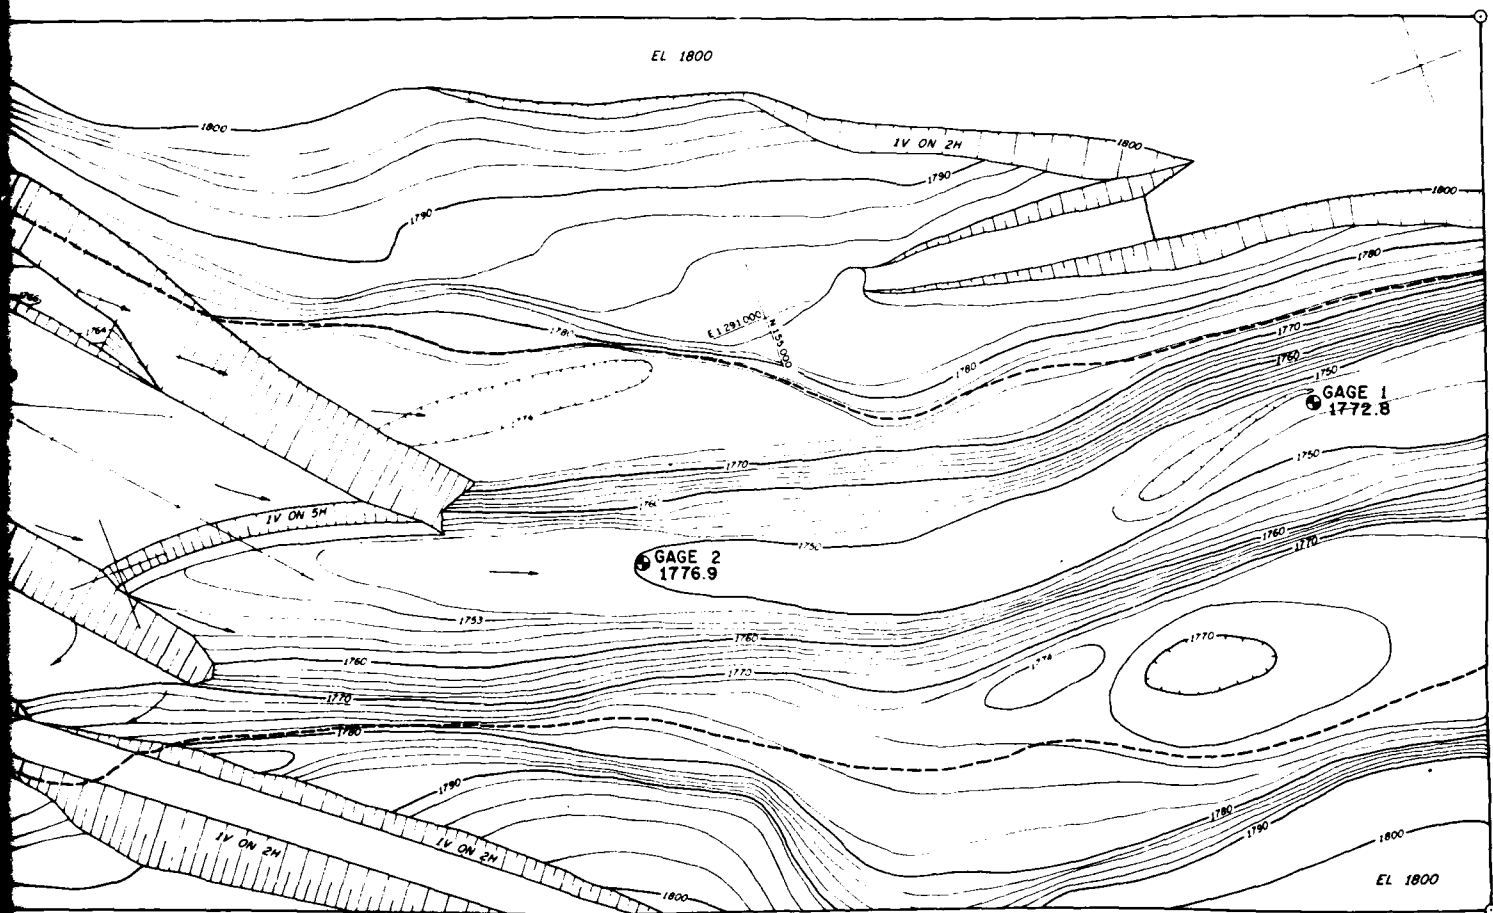
PLATE 19

ORIGINAL DESIGN

FLOW CONDITIONS  
SPILLWAY CHANNEL  
RIVER DISCHARGE 49800 CFS

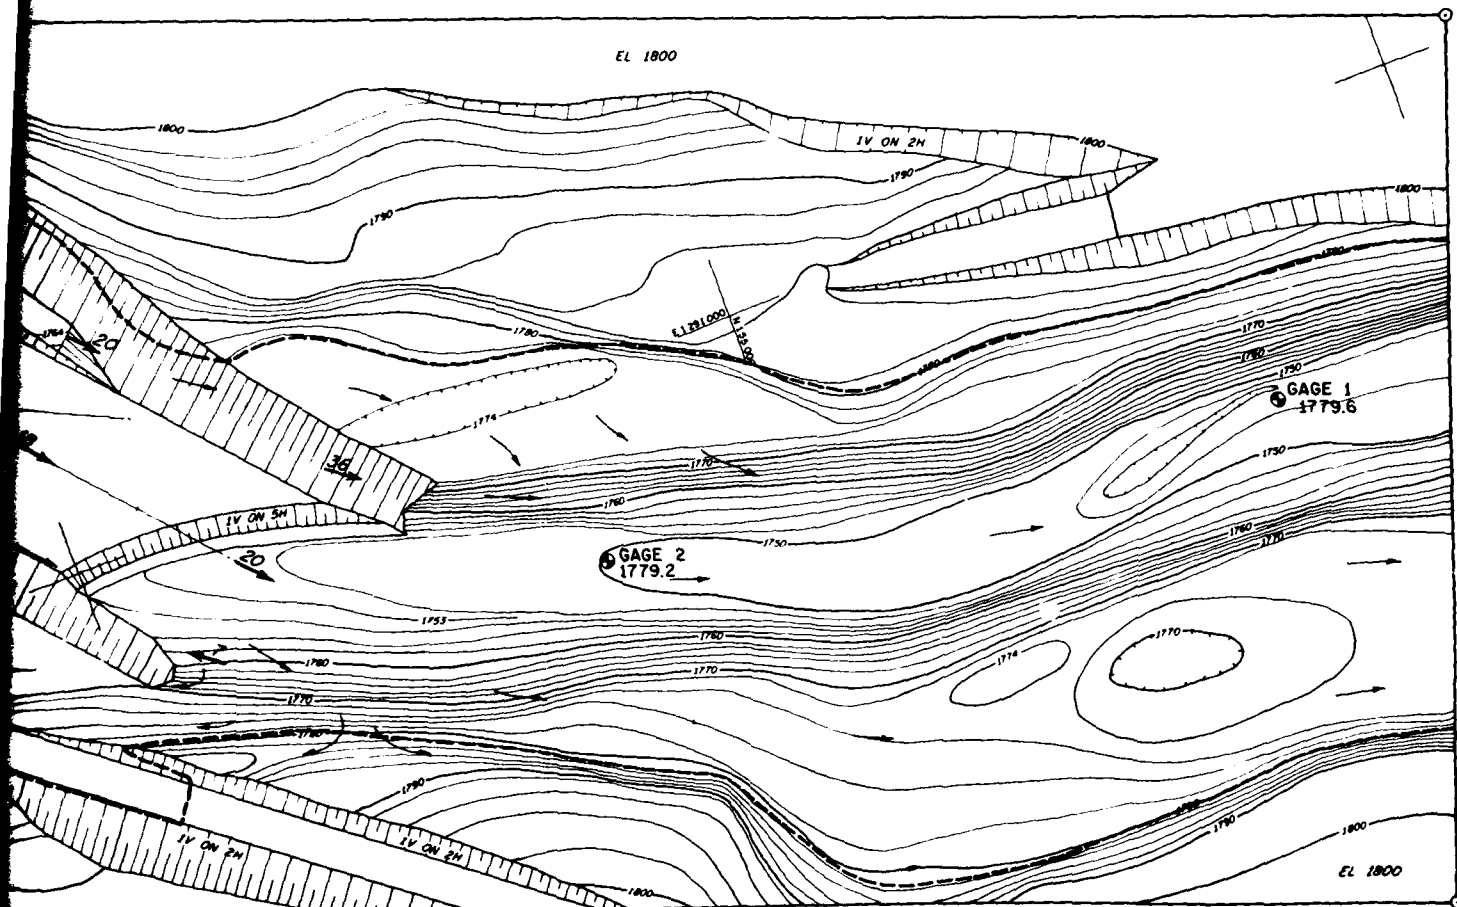
PLATE 20

ORIGINAL DESIGN

FLOW CONDITIONS

RIVER DISCHARGE 99 500 CFS

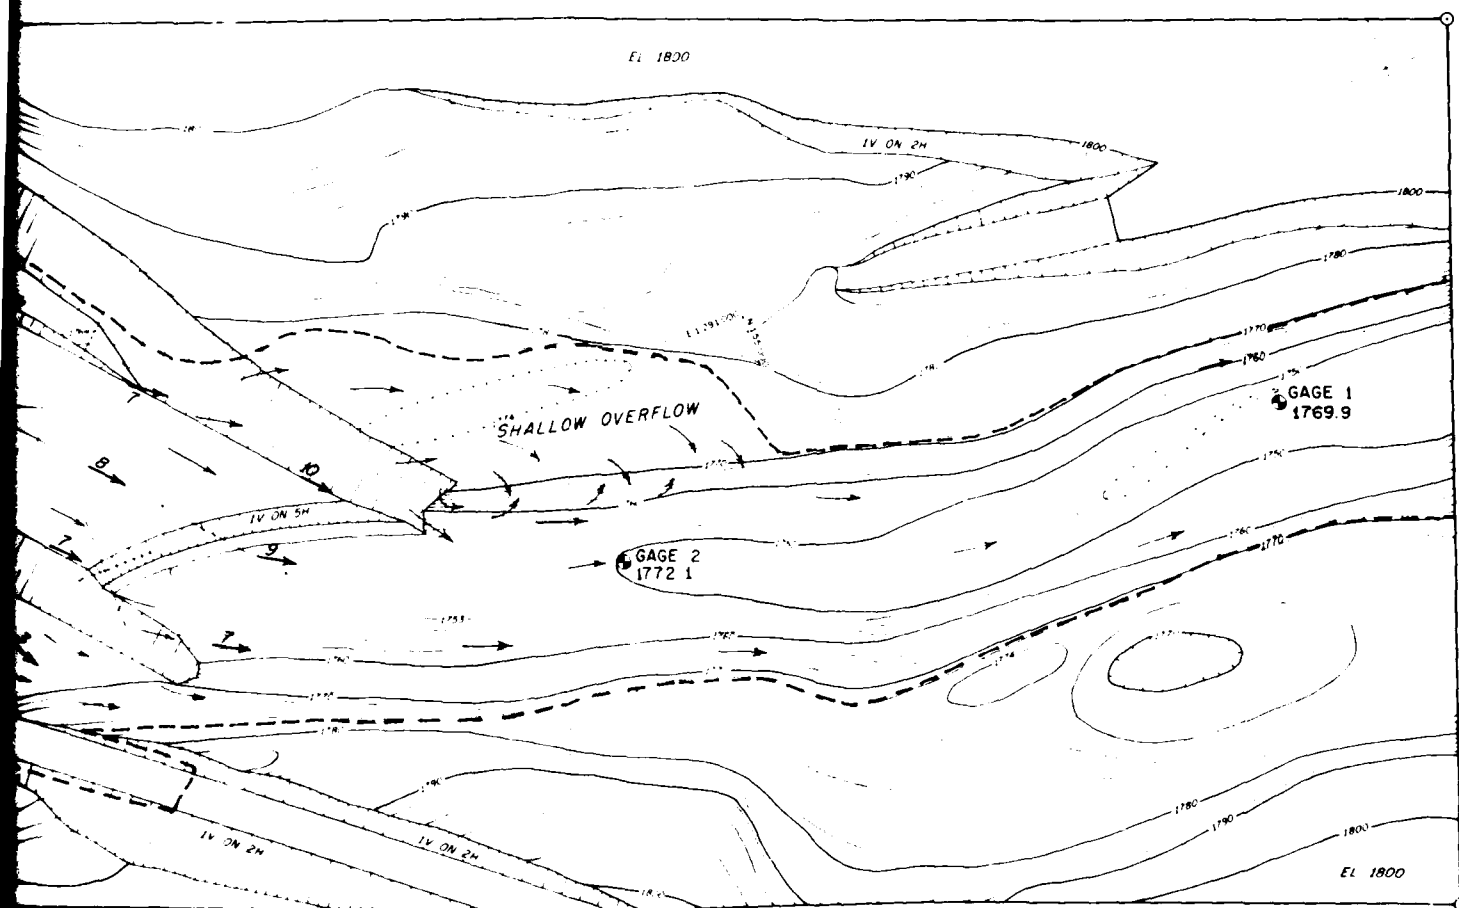
PLATE 23

REVISED DOWNSTREAM CHANNEL

FLOW CONDITIONS

RIVER DISCHARGE 35 600 CFS

26. Flow conditions with the revised transition for spillway discharges of 29,700 to 93,600 cfs are shown on plates 23 to 25. The longer transition did not noticeably improve flow conditions.

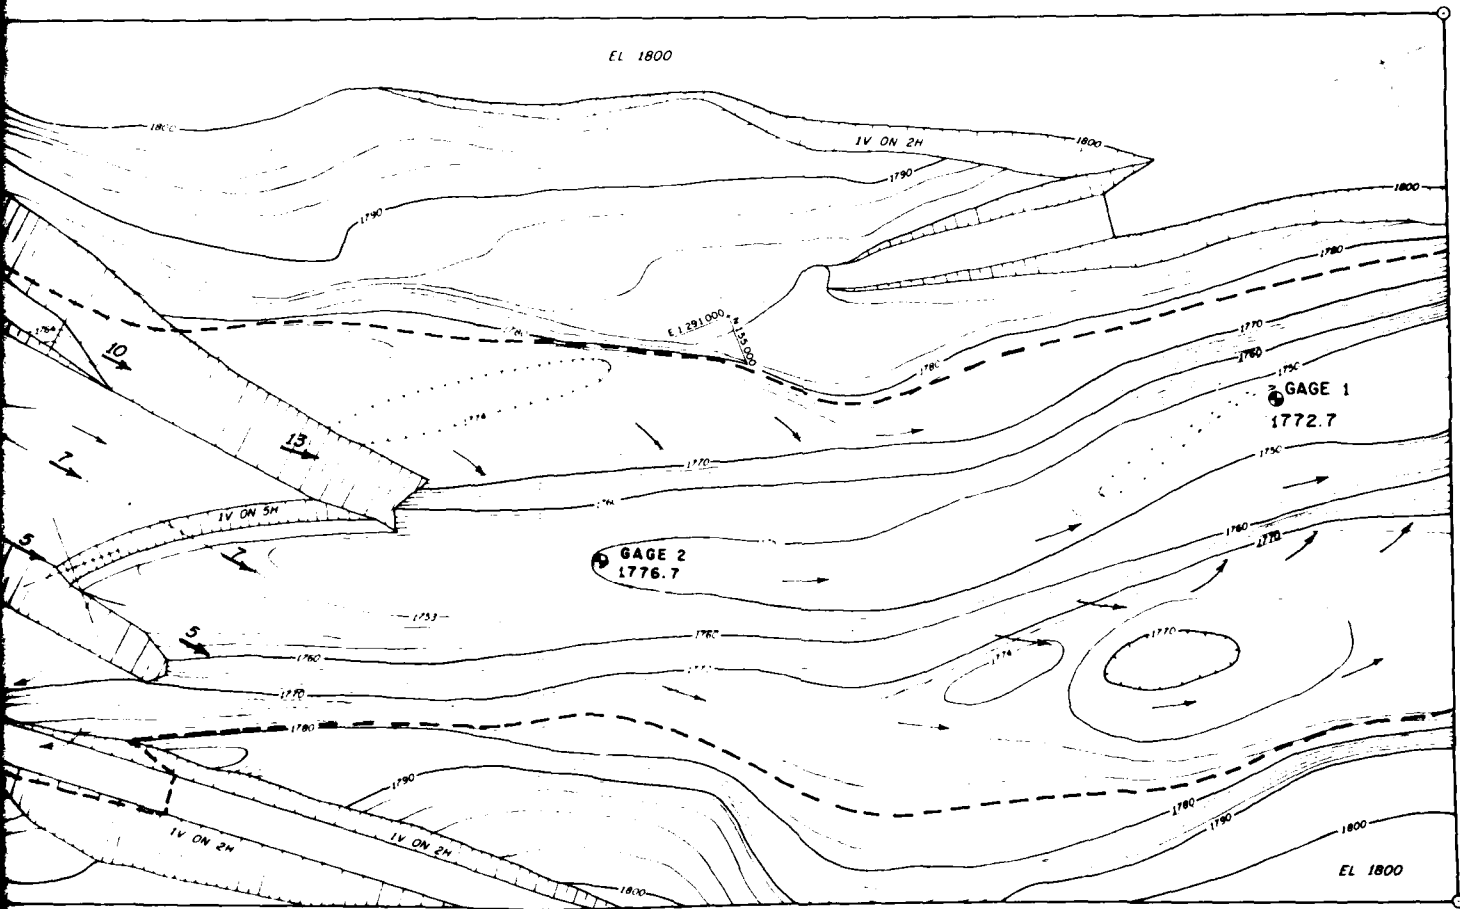
REVISED DOWNSTREAM CHANNEL

FLOW CONDITIONS  
 SPILLWAY CHANNEL  
 RIVER DISCHARGE 49 800 CFS

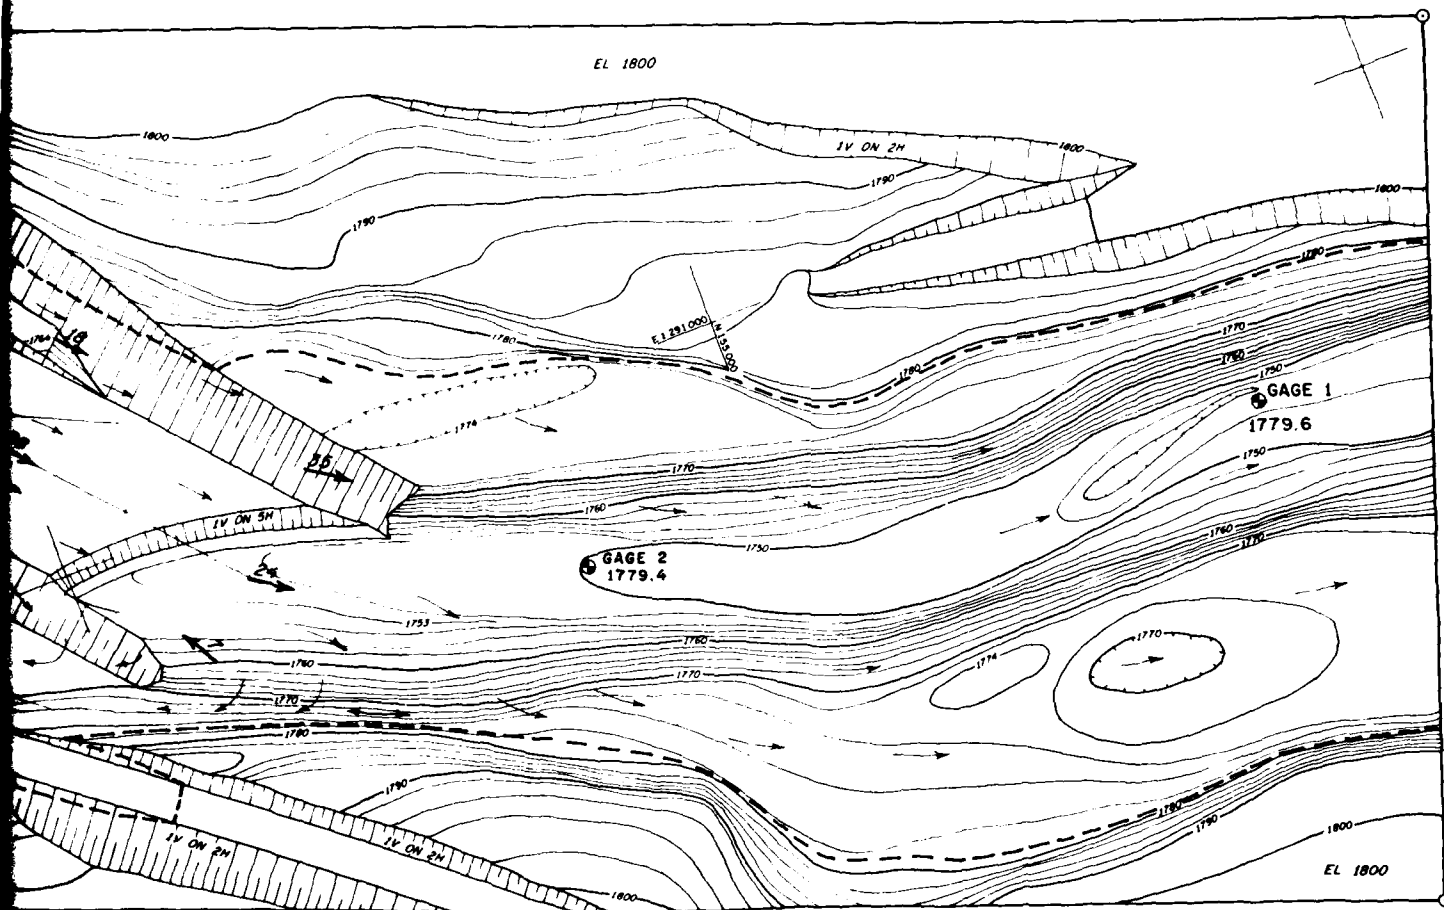
REVISED DOWNSTREAM CHANNEL

FLOW CONDITIONS  
SPILLWAY CHANNEL  
RIVER DISCHARGE 99 500 CFS

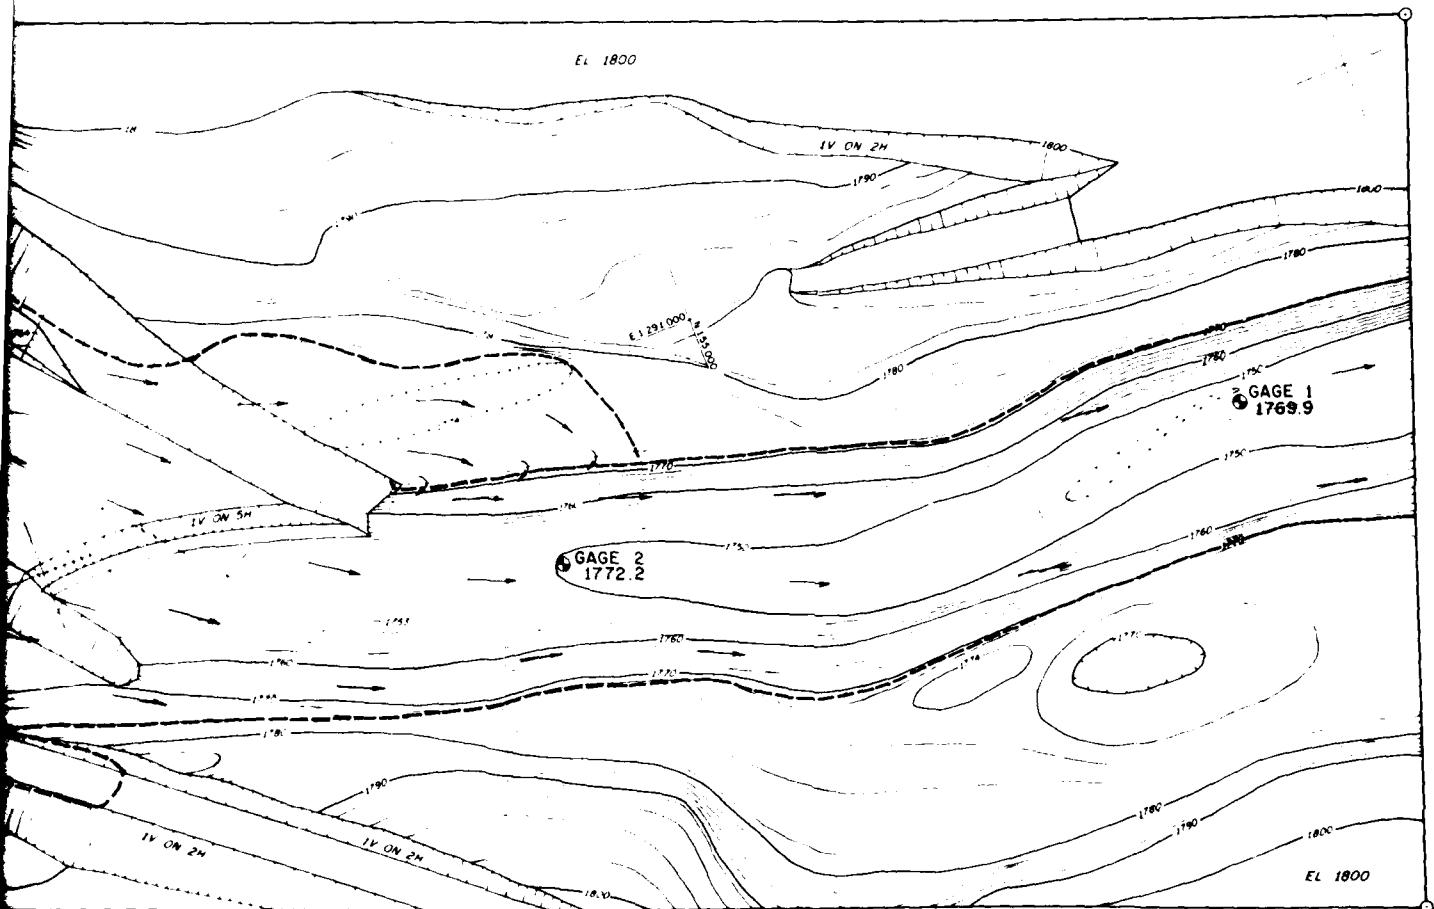
PLAN B PLUNGE POOL

FLOW CONDITIONS  
 SPILLWAY CHANNEL  
 RIVER DISCHARGE 35 600 CFS
